## Waste Tank Clogged

Tech Note Number: 663

Applicable Models: AnaJet *SPRINT* printer series

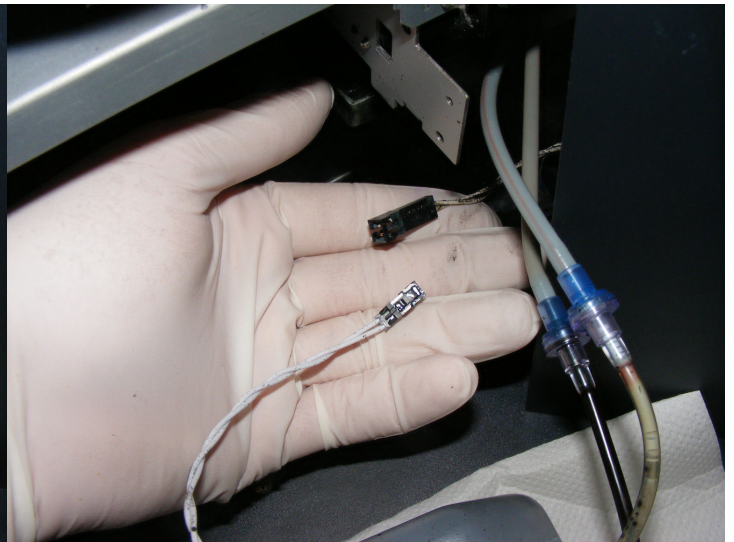
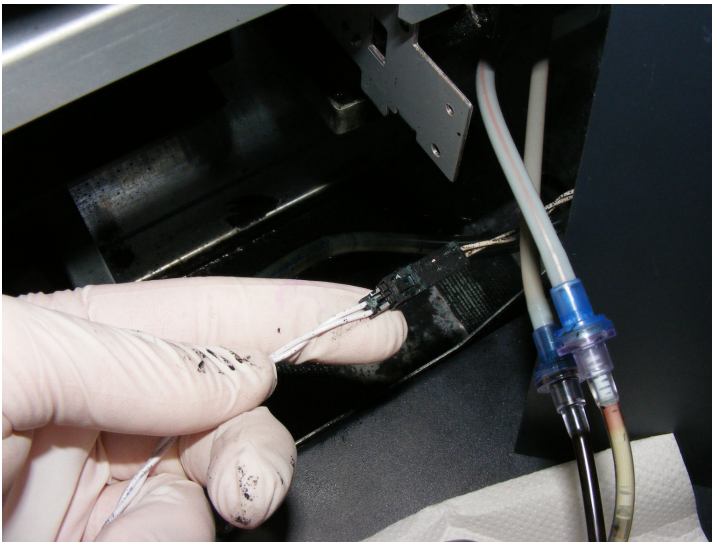
Diagnosis: Ink will not drain from waste tank.

Solution: If printer has ink in waste tank and sits for some time the ink can start to clog inside the waste tank. This is most likely from the white ink drying up. To fix you will just need to remove the tank then unclog where it drains with a paper clip.
